Trouble Shooter

Pedal Power

Clutch Player

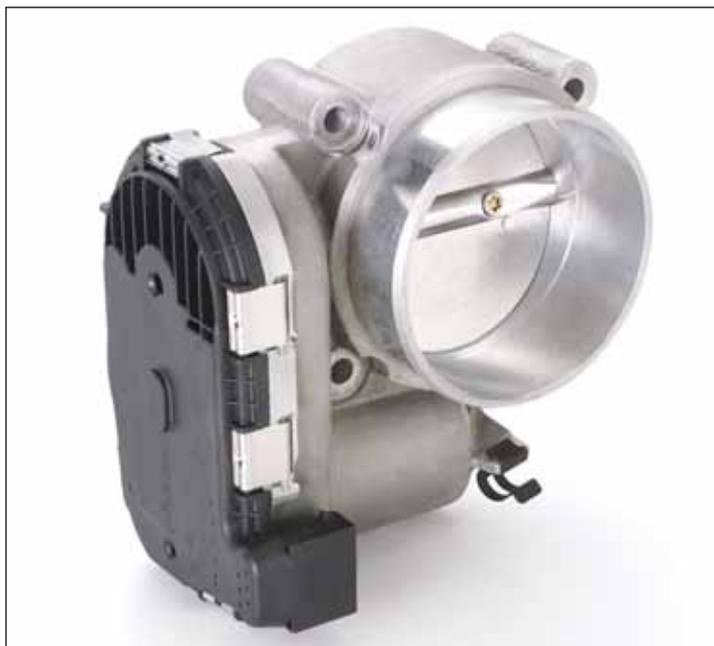
The only physical connection between the accelerator pedal and the throttle plate inside the throttle housing (shown) on late-model vehicles are the wires in the wiring harness that run between them and the PCM. Anything that disrupts the flow of information between these two important parts demands immediate attention.

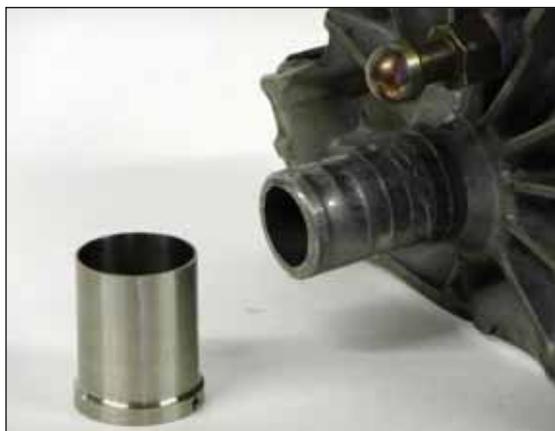
Rough clutch operation may be caused by a damaged release bearing guide sleeve (also colloquially referred to as the *quill*). This demonstration bellhousing fragment (with substantial quill damage) illustrates how a thin stainless-steel sleeve can be installed to return the transmission to service without additional parts replacement.

Even a small amount of wear or damage in this area can cause the clutch to jerk or chatter as it's engaged. The customer may also complain that the pedal feels rough or notchy, or that it feels like it's sticking as it's depressed or released. Besides making the clutch pedal difficult to operate, these problems also can lead to premature clutch disc and/or release bearing failures. As extra, unwanted clearance develops between the guide and release bearing, the release bearing and fork may rattle when the clutch is released. This accounts for the rattling noise your customer was complaining about.

It may be difficult to determine the actual cause of the damage. Some say the clutch release bearing fork may be placing a side load on the release bearing as it moves in and out on the release bearing guide surface. Over time, this may lead to wear on the guide's aluminum surface. After all, the aluminum is much softer than the hardened steel inner diameter of the release bearing. The condition may be aggravated by keeping the clutch disengaged in traffic for long periods, rather than shifting to Neutral and waiting to shift back into gear. Regardless of the cause, the damage is real.

Installation of the stainless-steel sleeve is straightforward. Depending on how badly damaged the original clutch release bearing guide surface has gotten, you may need to spend a little time dressing it with a file. Even sleeves that look pretty far gone can apparently be salvaged. The replacement sleeve slides over the original and must sit square before its setscrews are tightened.

The new release bearing has a slightly oversized inside diameter, to match the kit's stainless-steel replacement sleeve. A standard-size release bearing won't fit, which is why a notification sticker is included. The sticker includes information about the modification and the proper replacement release bearing to use. Placing the notification sticker under the hood alerts any other technician who may need to work on the clutch or transmission in the future.
