Trouble Shooter

Vehicle systems that rely on wheel speed sensors for their operation have been with us for some time. The systems and the sensors continue to evolve, requiring new service techniques.

Magnetic Attraction

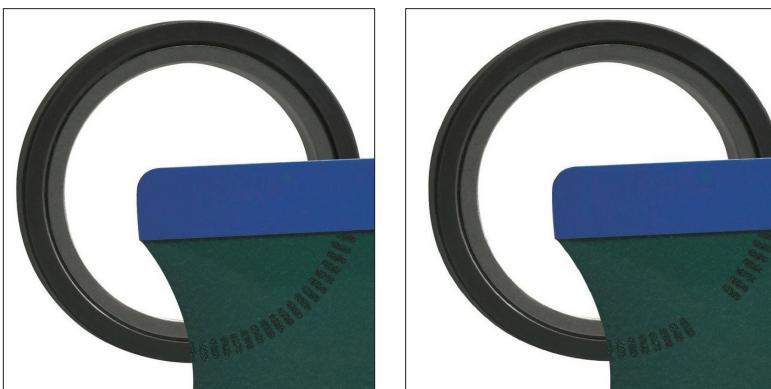
This magnetic sensor ring test card (Part No. 760130) contains a sheet of film that's sensitive to magnetic fields. Placing it next to a wheel bearing that includes an integrated rubber seal that has been enriched with iron dust will reveal the seal's magnetic fields. The image on the left shows a bearing with an unbroken, even pattern that can be easily detected by the adjacent wheel speed sensor. The image on the right reveals a large gap where no fields are detected, possibly caused by physical damage to the seal.

film will not show a pattern. The film can also be used to diagnose a break in the magnetic sensor ring caused by damage, as seen in the photos on page 6. ATE and other manufacturers offer test cards with a protective sleeve that are designed for this purpose.
