# HISTORIC MONEL—PART II: TESTING AND ANALYSIS OF ATMOSPHERIC CORROSION PRODUCTS

A look at Monel after decades of exposure to the environment shows more work is needed to address the lack of scientific research and conservation literature.

*James E. Churchill,\* Columbia University, New York and Kreilick Conservation, Pennsylvania*

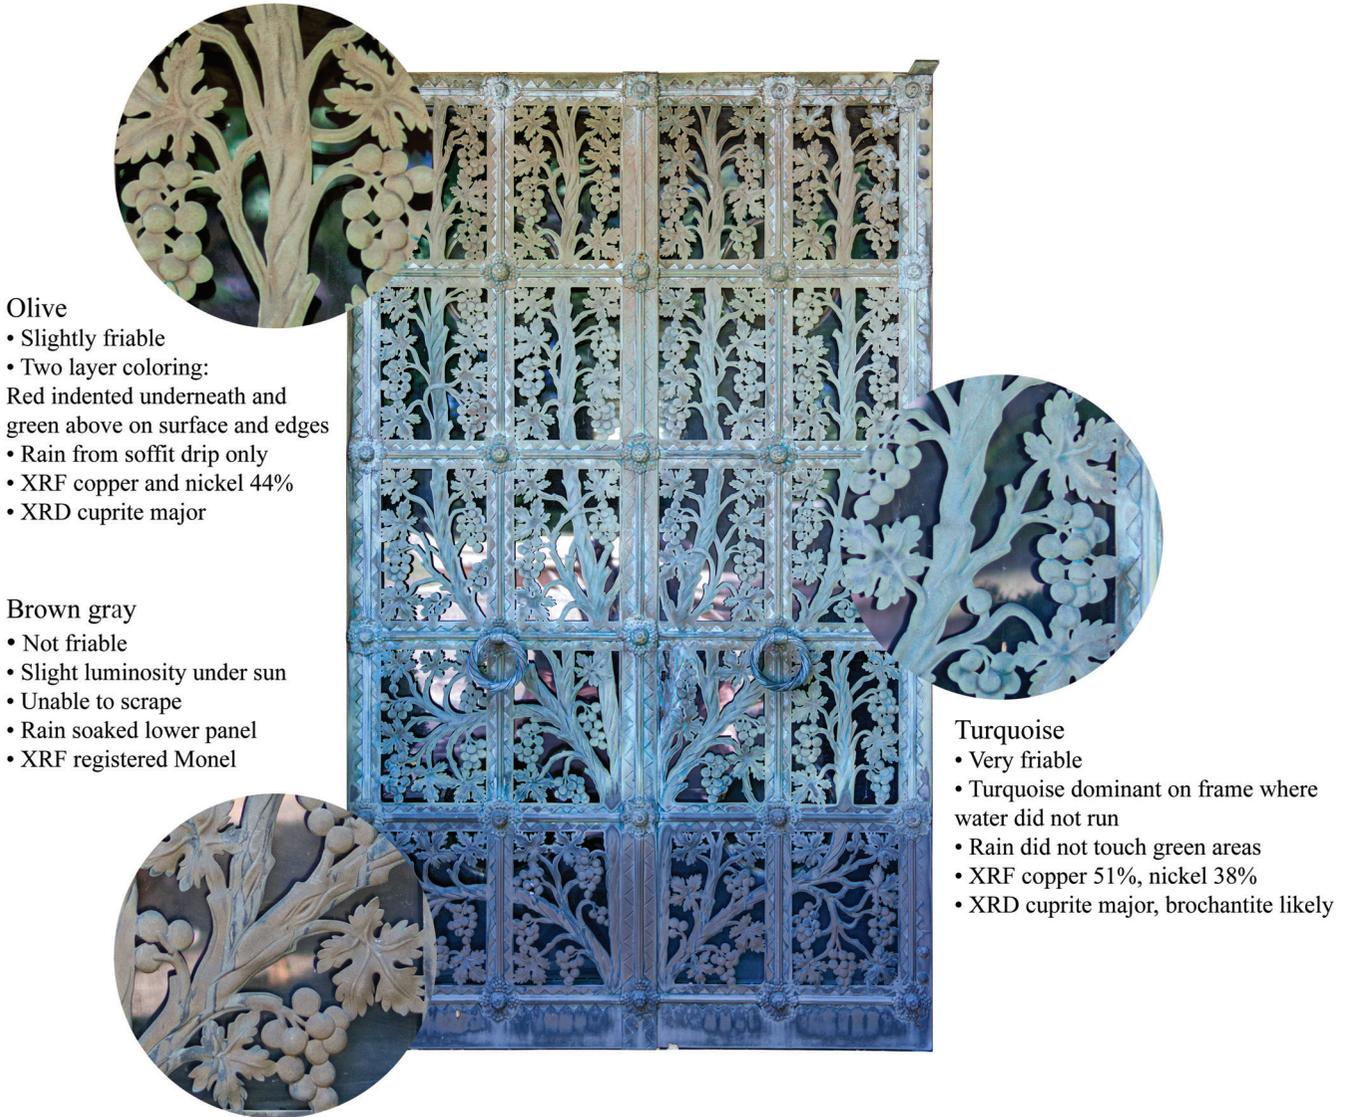
**Jesse I. Straus Gate:** Handcrafted by the Samuel Yellin workshop in 1929, the Straus gate, one of three for each heir to the Macy's fortune, depicts a grape and leaf design. A glass filled metal frame with ventilation was likely installed later. Visual examination revealed a relief flattened by friable turquoise corrosion, olive coloring along the upper row from a green top and red lower layer, and brownish gray on the base plate. XRF showed vastly different elemental readings. Turquoise areas registered copper up to 51%, nickel 37%, and sulfur 3%, versus the typical Monel readings at the base. A thinner turquoise layer on the interior saw copper dropping below 40%, showing the importance of exposure. XRD revealed major phases of cuprite and brochantite around the turquoise areas and possible chalcantite, but the brown layer was non-scrapable and could not be identified. Samples were analyzed using copper radiation tubes with scans run over the range of 5 to 80°, a step size of 0.0131° and an accumulated counting time of 500 s/step. Such thin layers could likely only be studied through x-ray photoelectron spectroscopy, XANES or XAFS but were beyond the scope of this study. A lack of identification of the base metal, hydrates and hydroxides by the databases used showed the limitations of testing an under-researched alloy.

**Fig. 2** — Visual and technical identification of the Jesse I. Straus gate at Woodlawn cemetery.

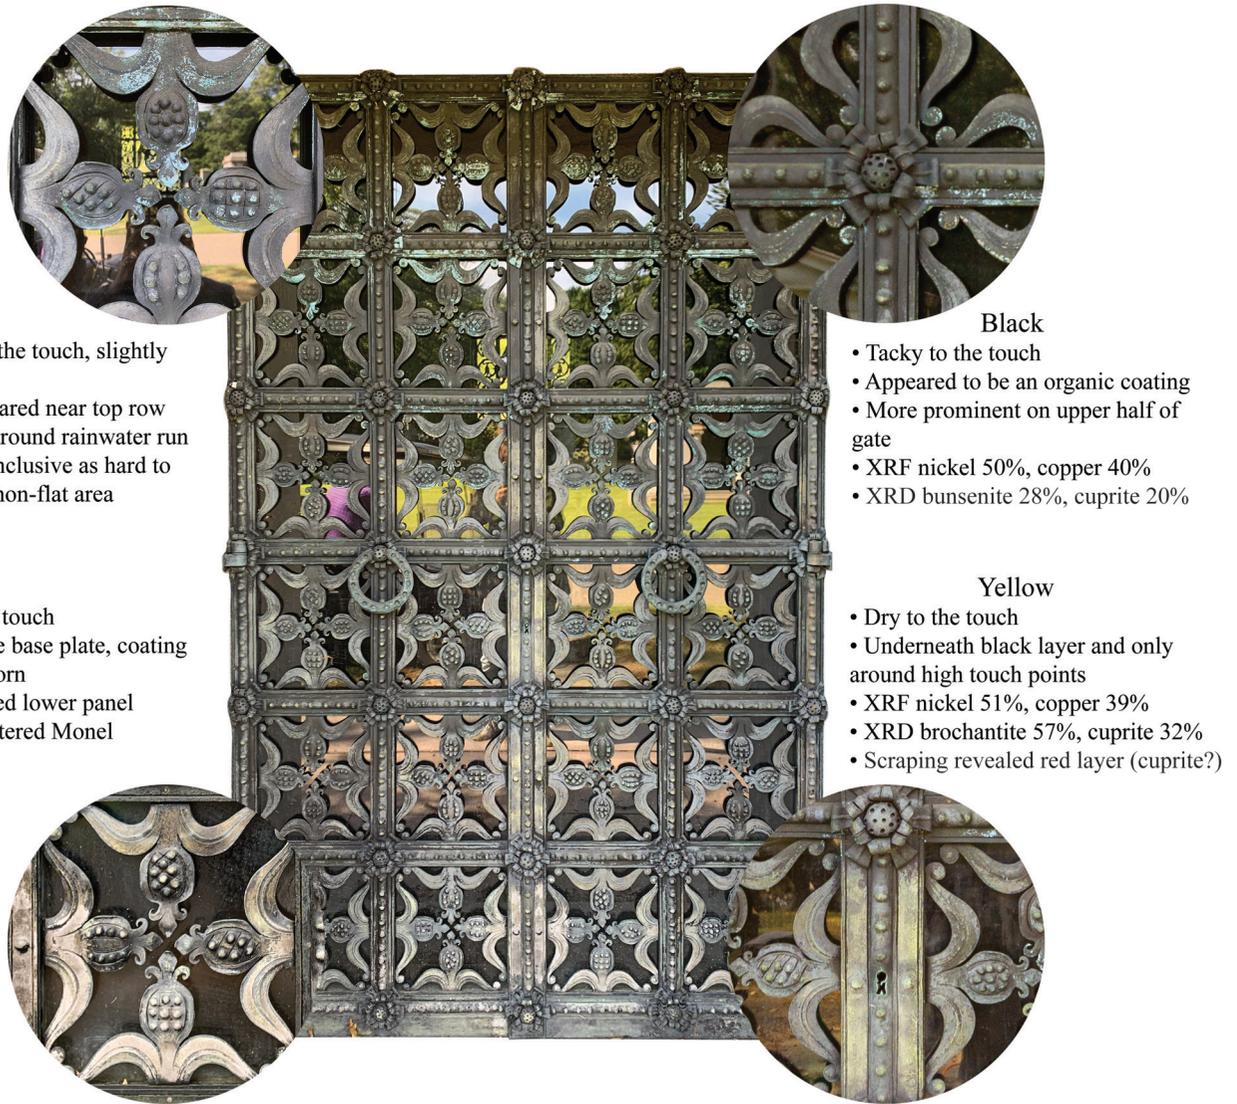
**James Norman Hill Gate:** Worked in the same shop, the Hill gate, built for an heir of the Northern Pacific railroad fortune, depicts seed motifs topped by fleur-de-lis, ensconced in leaves. While also housing a glass filled metal frame, a lack of ventilation netting, in comparison to Straus, has impacted corrosion significantly on the rear side. Examination revealed a waxy black coating over the majority of the exterior, spotty turquoise corrosion at the top, a yellow area around the high-traffic hand area, and gray at the base. Turquoise was difficult to measure with the XRF due to a lack of flat surface, but the elements of the handle presented copper of 47% and nickel of 41%, while the black and

yellow areas 40% and 51%. In all three, sulfur was elevated 2-3%. The gray base area registered Monel. XRD, only successful for the black and yellow areas, confirmed roughly equal amounts of cuprite, bunsenite, clinoatacamite, and a hydrated nickel compound for the former, but nearly 60% bunsenite and 30% cuprite for the latter, with minor tenorite.

While the Straus gate revealed little in organic analysis, the Hill gate was positive for a beeswax application. Such treatment may have impacted the weathering of the Monel and should be further investigated<sup>[4]</sup>. Visual analysis of both gates after rain revealed turquoise areas were dry, the top panels received water drip from soffits and the bases were all but saturated. Given some green run-off seemed to stain

#### Turquoise

- Grainy to the touch, slightly friable
- Only appeared near top row
- Grouped around rainwater run
- XRF inconclusive as hard to process on non-flat area

#### Gray

- Dry to the touch
- Only at the base plate, coating appeared worn
- Rain soaked lower panel
- XRF registered Monel

#### Black

- Tacky to the touch
- Appeared to be an organic coating
- More prominent on upper half of gate
- XRF nickel 50%, copper 40%
- XRD bunsenite 28%, cuprite 20%

#### Yellow

- Dry to the touch
- Underneath black layer and only around high touch points
- XRF nickel 51%, copper 39%
- XRD brochantite 57%, cuprite 32%
- Scraping revealed red layer (cuprite?)

Fig. 3 — Visual and technical identification of the James N. Hill gate at Woodlawn cemetery.

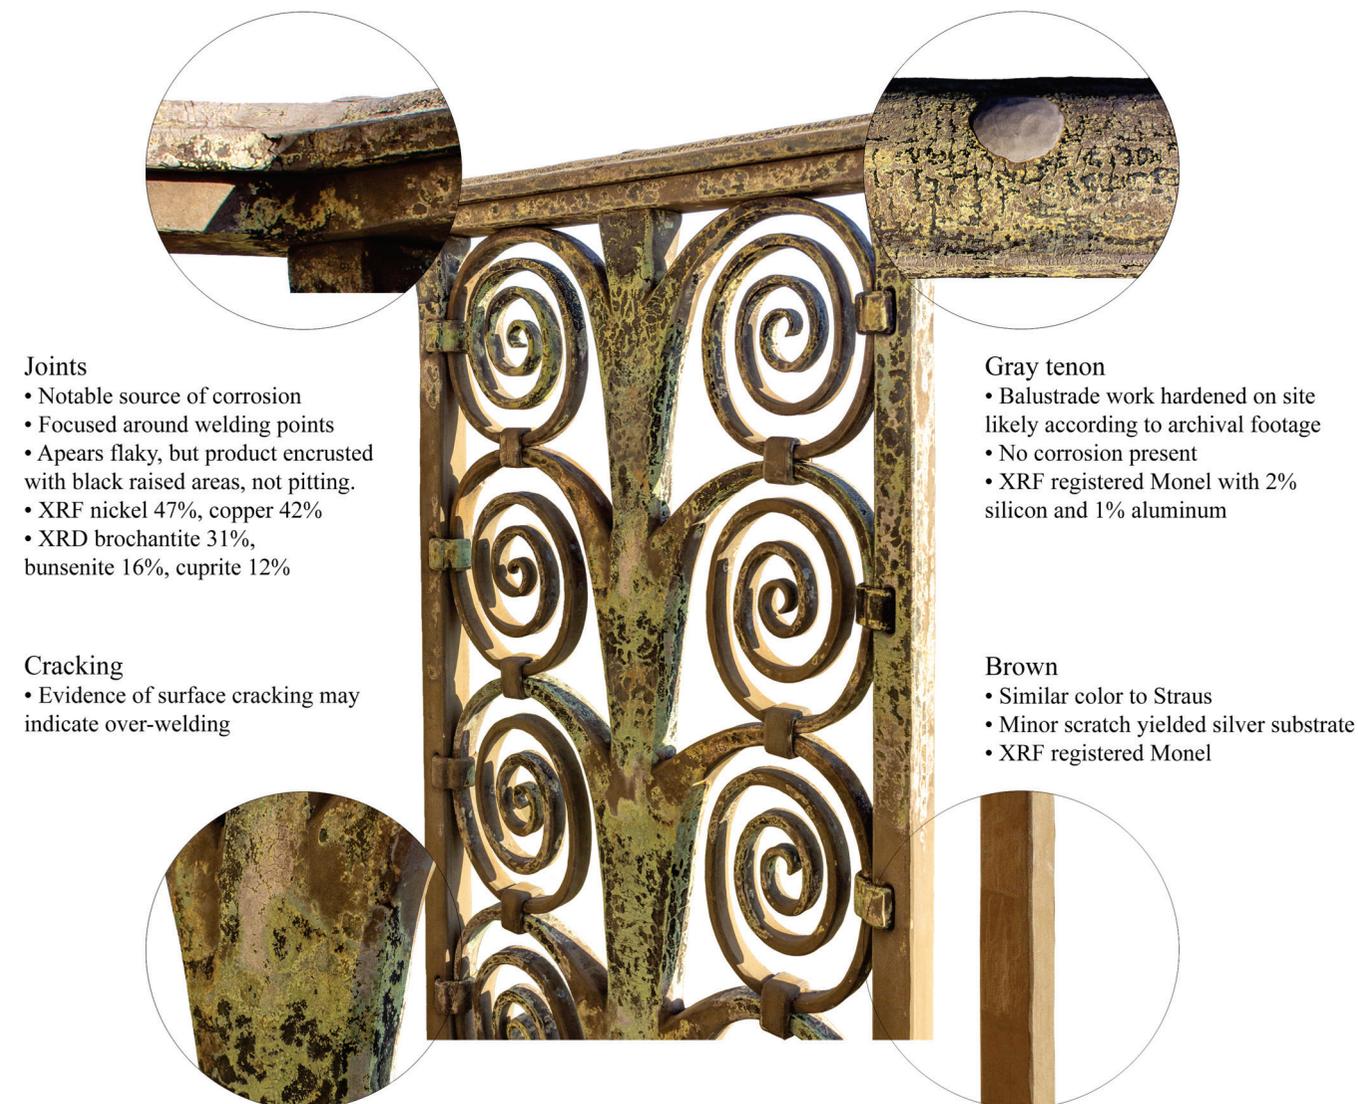
Investigation of the exterior surfaces included the railing in the tower of Glencairn on the ninth floor, which had entirely different coloring. While largely brown, the decorative scrolls, joints, and weldings showed a clear outbreak

of black and yellow green mottled corrosion product. Firmly encrusted, the black was raised from the now yellowed surface and was most noticeable next to hammered tenon joints through the balustrade, which was entirely matte gray with no corrosion whatsoever. The majority of brown areas, along with the tenon joint, registered Monel. The yellow and black area, however, registered 49% nickel and 41% copper, with solvents raising the copper reading as high as 54% and sulfur from 2.3% to 3.8%. XRD for these areas revealed over 30% brochantite, 15% bunsenite, and slightly less cuprite.

#### Joints

- Notable source of corrosion
- Focused around welding points
- Appears flaky, but product encrusted with black raised areas, not pitting.
- XRF nickel 47%, copper 42%
- XRD brochantite 31%, bunsenite 16%, cuprite 12%

#### Cracking

- Evidence of surface cracking may indicate over-welding

#### Gray tenon

- Balustrade work hardened on site likely according to archival footage
- No corrosion present
- XRF registered Monel with 2% silicon and 1% aluminum

#### Brown

- Similar color to Straus
- Minor scratch yielded silver substrate
- XRF registered Monel

**Fig. 4** — Visual and technical identification of the tower railing at Glencairn, Bryn Athyn.
