# POST-FIRE METALLURGICAL ASSESSMENT OF GALVANIZED ANCHORS SUPPORTING A TELECOMMUNICATIONS TOWER

Mehrooz Zamanzadeh, FASM\* and Anil Kumar Chikkam\*  
Matergenics Inc., Pittsburgh

**A zinc-coated tower undergoes rigorous field testing and laboratory analysis to determine if the material integrity was preserved despite exposure to fire.**

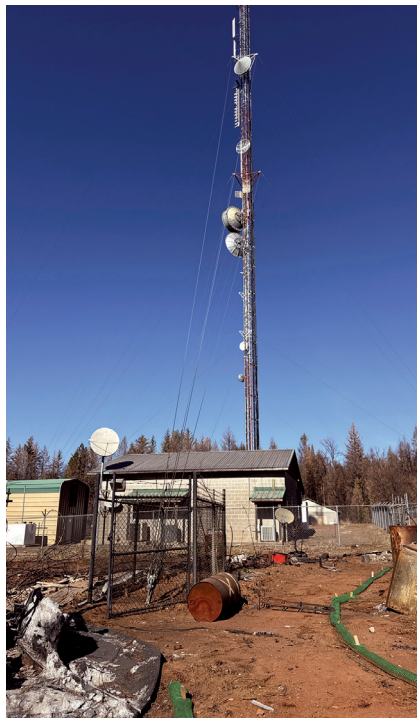
**Fig. 1** — Telecommunications tower featured in this case study.

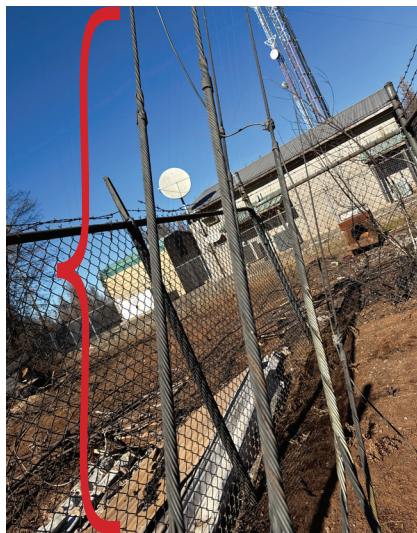
**Fig. 2** — Photograph showing guy wires of anchor BB with visible discoloration.

**Visual examination.** Figure 1 shows the condition of the site. The site included six anchor foundations comprised of galvanized steel I-beam shafts. Visual examination revealed that anchors B and BB exhibited dark deposits resembling soot or char, indicating exposure to wildfire. Anchors A, AA, C, and CC remained clean and free of discoloration, suggesting they were either shielded or located in a less affected area. Figures 2 through 5 show the condition of anchors BB and CC.

To mitigate long-term risks, it is recommended to clean affected areas—ideally with pressure washing—to remove potentially corrosive residues and to consider installing EnviroZense for real-time corrosion and wildfire temperature monitoring. These types of sensors enable remote assessment and help ensure the continued structural integrity and reliability of the tower should future wildfire events occur.

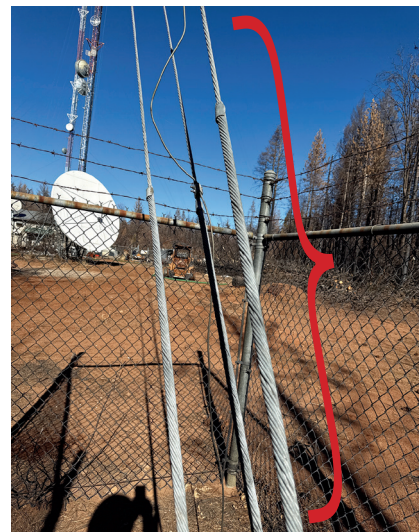
**Fig. 3** — Photograph showing guy wires of anchor CC.

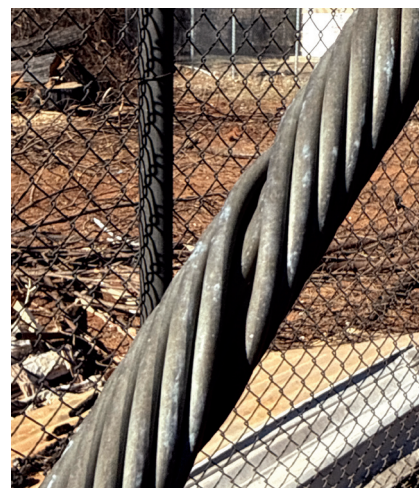
**Fig. 4** — Closer view of one of the anchor BB guy wires clearly shows discoloration. Dark looking deposits are byproducts of combustion.

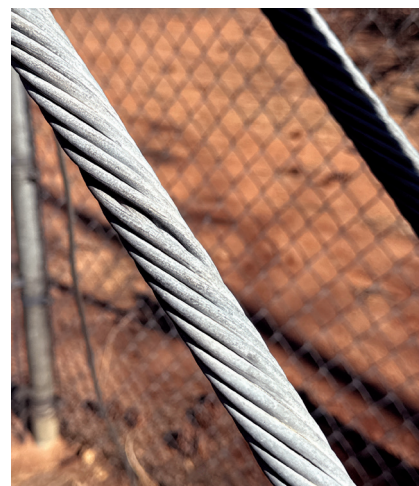
**Fig. 5** — Closer view of one of the anchor CC guy wires clearly shows no exposure to wildfire.

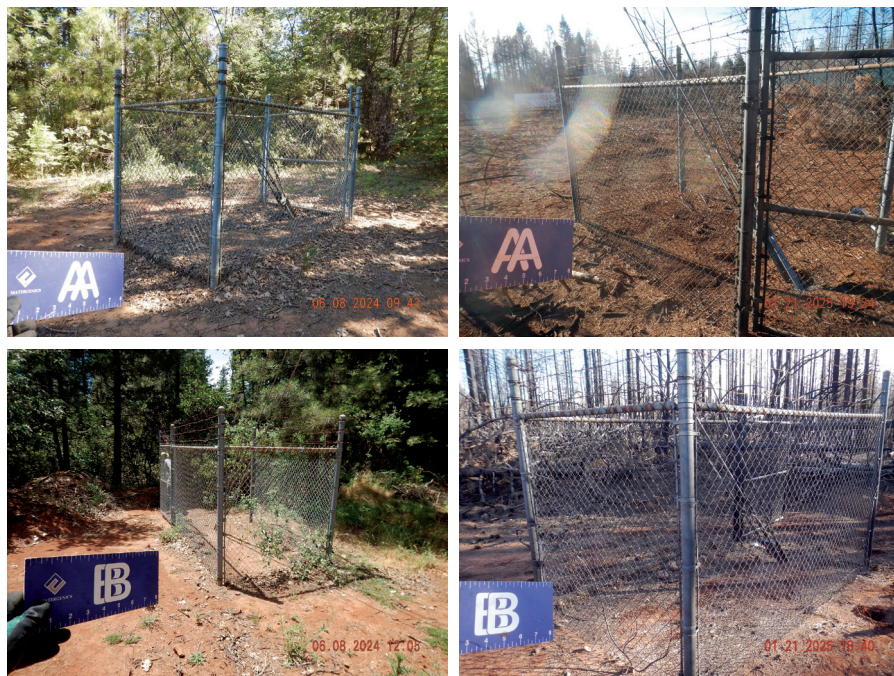
**Fig. 6** — Photographs showing that the site is affected by wildfire. Images on the left were taken during the inspection on June 8, 2024, while images on the right were captured during the inspection on January 21, 2025.

The site was impacted by wildfire. As shown in Fig. 6, a comparison of the conditions around anchors AA and BB with the site conditions during the previous inspection on June 8, 2024, reveals significant changes. Vegetation in the surrounding area was severely affected by the wildfire with noticeable damage including burnt and scorched plant life. These visual changes highlight the wildfire's impact on the site and its immediate surroundings.

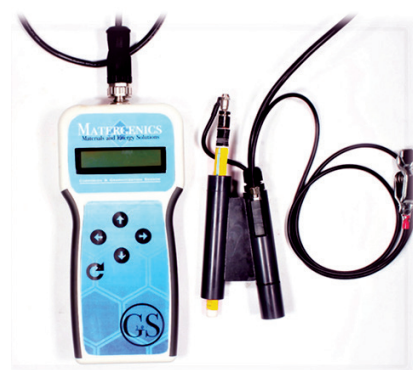
**Fig. 7** — Zee Probe from Matergenics.

zinc, a zinc-iron intermetallic layer, or bare steel. Anchor AA, which was unaffected by fire, showed readings between  $-0.91$  and  $-0.97$  V, confirming a well-preserved galvanized coating. In contrast, fire-exposed anchors B and BB showed readings from  $-0.56$  to  $-0.88$  V, indicating partial degradation of the zinc layer, with some regions likely retaining intermetallic layers or thermally altered zinc. These results suggest that although some thermal damage occurred, the galvanizing layer still offers a degree of corrosion protection.

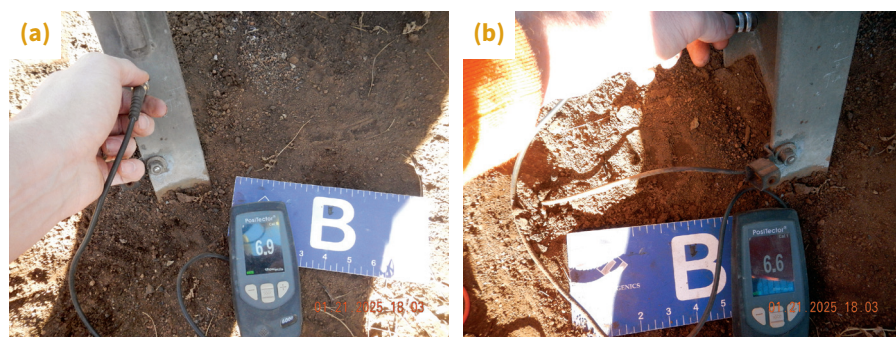
**Fig. 8** — Photographs show galvanized layer thickness of anchor B (I-beam): (a) Galvanized layer thickness at flange; and (b) galvanized layer thickness at web.

of anchor shafts and fan plates for anchors AA (unexposed), B, and BB (wildfire-exposed) was measured using a coating thickness gauge, with representative images shown in Fig. 8 and summarized results in Table 1. A comparative analysis was conducted to assess whether wildfire exposure caused any degradation or thinning

of the galvanized coating. The measurements revealed generally consistent thickness across all anchors, indicating no significant loss of the protective zinc layer due to fire. One higher-than-expected reading at anchor BB was likely due to surface deposits or

contaminants affecting the measurement rather than a true variation in coating thickness.

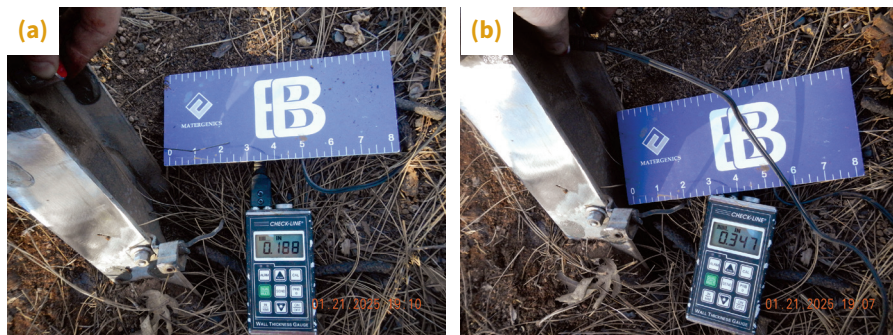
**Fig. 9** — Photographs showing wall thickness of anchor BB (I-beam): (a) Wall thickness at web; and (b) wall thickness at flange.

**Wall thickness measurement using an ultrasonic gauge.** Ultrasonic measurements were taken to assess the wall thickness of the web and flange sections of I-beam-shaped anchors AA (unexposed), B, and BB (wildfire-exposed), as shown in Fig. 9, with results summarized in Table 2. A comparative analysis evaluated whether wildfire exposure caused any material loss that could affect structural performance. Wall thickness values across all three anchors were found to be consistent, with no significant thinning observed. These findings indicate that the wildfire exposure did

not compromise structural integrity of the anchor shafts.

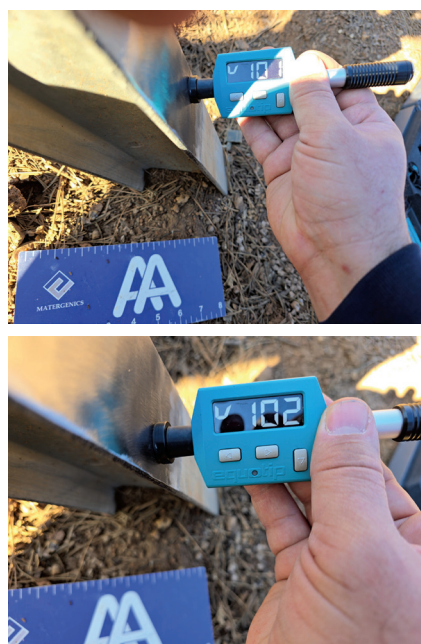
**Fig. 10** — Photographs showing Vickers hardness values of anchor AA (flange).

**In-situ hardness test.** Vickers hardness testing was conducted on the flanges of I-beam-shaped anchors AA (unexposed), B, and BB (wildfire-exposed) using a portable hardness tester. To access the base metal, flange surfaces were ground to expose the underlying carbon steel, and zinc-rich paint was applied afterward to protect the exposed areas. A representative image of the testing is shown in Fig. 10, and the recorded values are summarized in Table 3. A comparative analysis revealed consistent hardness values across all three anchors with no significant abnormalities observed. These results indicate that wildfire exposure did not adversely affect the material hardness or structural integrity of the anchors.

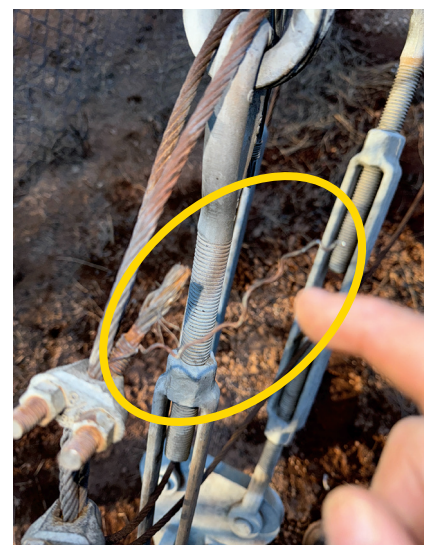
**Fig. 11** — Small strand sample from wire rope at anchor BB removed for examination.

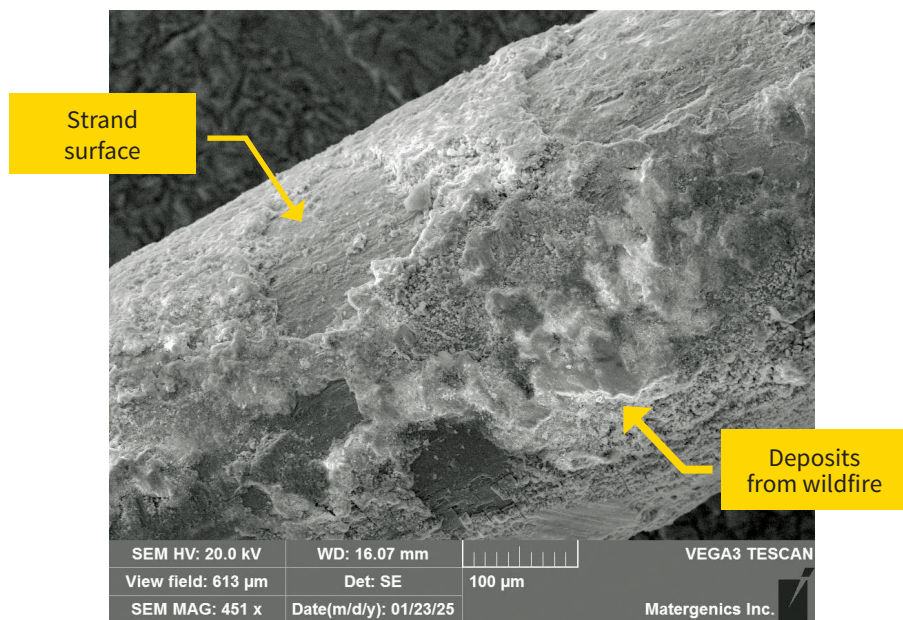
**Fig. 12** — EDS data clearly shows that the surface of the strand has elemental composition similar to the intermetallic phase on the galvanized steel surface and the oxides of zinc, which suggests the temperature was not high enough to melt the zinc and leave only the steel surface. EDS data of the deposits is similar to soot and fly ash.

was analyzed through EDS, with results showing significant variations (Fig. 12). Deposits primarily consist of carbon, oxygen, sodium, aluminum, silicon, potassium, iron, and zinc. Weight percentages for these elements in the deposits were as follows: C (6.19%), O (40.18%), Na (4.02%), Al (1.79%), Si (2.08%), K (0.39%), Fe (12.73%), and Zn (32.61%). Elemental composition of the strand surface itself showed a

slightly different distribution with iron at 44.70%, zinc at 36.89%, and oxygen at 17.28%, suggesting that the deposits are predominantly composed of soot and fly ash.

EDS data clearly indicate that the strand surface has an elemental composition similar to the intermetallic phase found on the galvanized steel surface and the oxides of zinc. This suggests that the temperature during

exposure was not high enough to melt the zinc and leave behind just the steel surface. EDS analysis of the deposits further confirms the composition is likely soot and fly ash, typical by-products of combustion or high-temperature exposure.

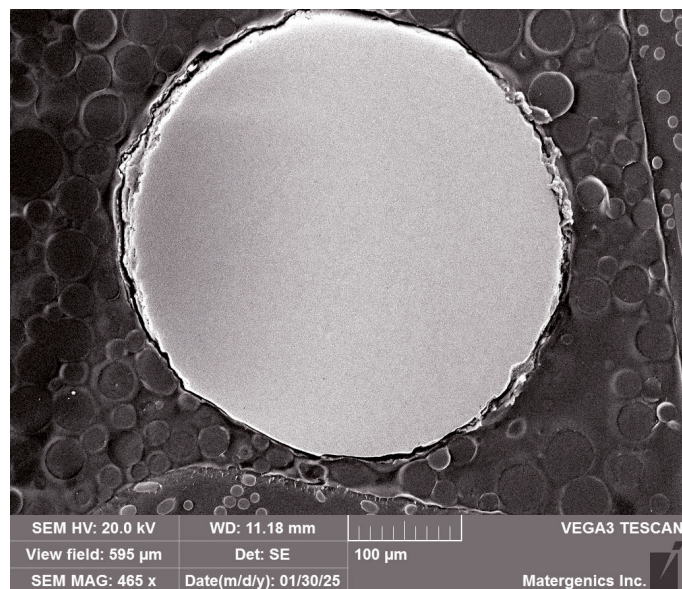
**Fig. 13** — SEM image shows cross-section of strand considered for examination at higher magnification.

Following SEM examination of the strand surface, a transverse cross-section was extracted from the strand sample. The cross-section was then ground and polished to a 1- $\mu\text{m}$  surface finish and subsequently etched using a 2% Nital solution. Figures 13 and 14 provide a comprehensive SEM analysis of the wire rope strand, focusing on its microstructure and the presence of a galvanized layer. Figure 13 shows the cross-section of the strand examined at a higher magnification to gain detailed insights into its structure. Figure 14 confirms the presence of a galvanized layer on the strand surface with the microstructure identified as martensite. The microstructure at the core of the strand is examined, and it is also found to consist of martensite. Consistency in the martensite microstructure between the surface

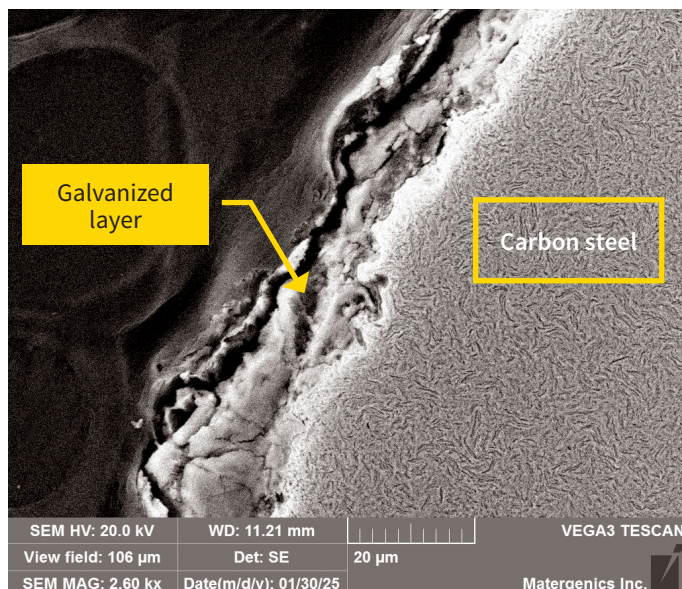
**Fig. 14** — SEM examination confirms the presence of a galvanized layer on the strand surface. Microstructure consists of martensite.

and core indicates that the temperatures during exposure were not high enough to alter the microstructure at the surface, which further suggests the strand did not undergo significant thermal degradation or phase transformation. This uniformity in microstructure across the surface and core confirms that the material's integrity was preserved, even under the conditions it was exposed to.
